HAD ENOUGH OF 3T SPINE ARTEFACTS?

A new installation at Trinity MRI eliminates troublesome dielectric effects in the spine.

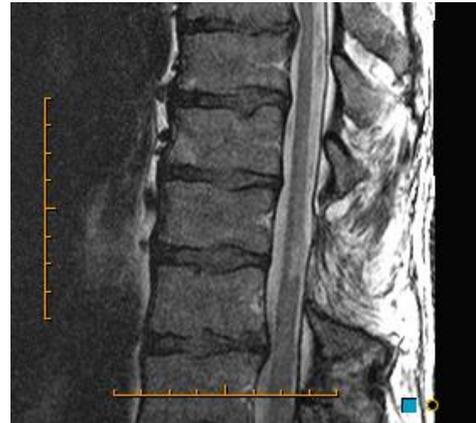
The Trinity MRI image on the same patient (right) shows an area of myelomalacia posteriorly within the thoracic cord adjacent to a laminectomy defect.

We also get several segments greater coverage with our new installation, reliably showing the lower cord on all examinations.
